IDENTIFYING INITIAL DAMAGE OF PALM OIL SCREW PRESS OF DRIVE SHAFT

ABSTRACT: Investigation was carried out because of the common failure at the screw press of drive shaft which made disruption on production activity of palm oil. Visual observation, interview and simulation were conducted. The finding supported by simulation using Nastran statistical software showed that the fracture occurred due to the fatigue. Based on simulation, it was known that the stress concentration occurred on the keyway of the tooth wheel holder. It was proved by visual observation which showed the attrition of keyway due to the friction between post and keyway continuously occurred in the drive shaft rotation. The continuously friction led to the loosening of the keyway. Furthermore, it made the strong impulse to the post keyway which finally caused the fracture at the keyway area. The continuously operating drive shaft caused the final fracture. The several characteristics of fatigue fracture could be seen from the fracture surface, such as the presence of residual fracture area, smooth surface and the presence of beach marks.

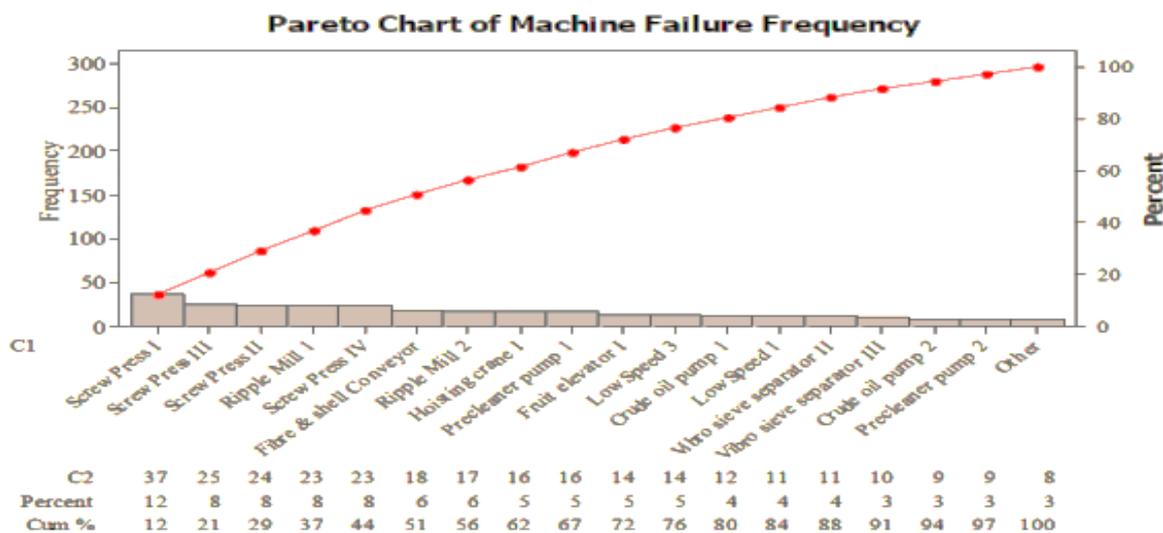
Figure 1. Frequency of failure process engineering at the MCC [3]

Figure 1 showed that the greatest frequency of failure happened at Screw Press. The frequent failure of the drive shaft on the Screw Press would reduce the productivity of the company . It automatically led

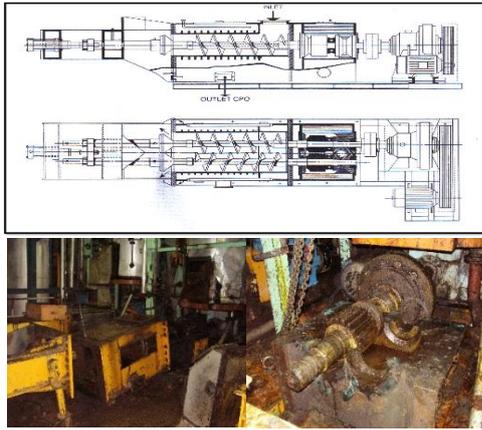
Figure 2. Screw Press
Source : Universal Steel and PT . Minamas

In component, if screw press was damaged, the process of mounting the drive shaft is the most complicated and it needs a lot of time. The high levels damage of screw press within a year will increase the downtime that would burden the cost of spare parts and the operations of the company.

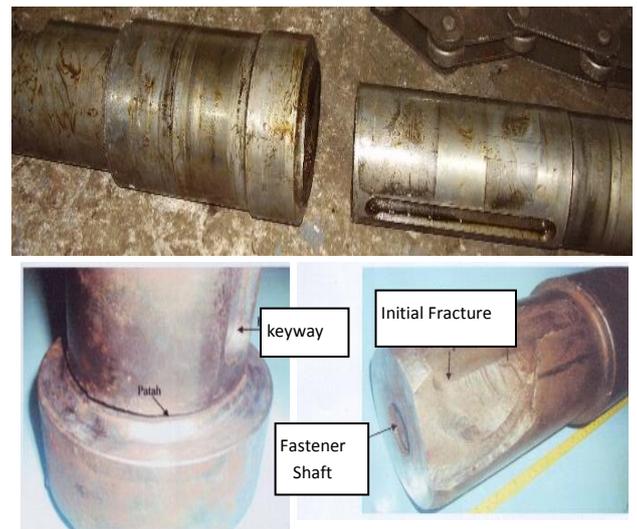
Figure 3. The fracture of screw press of the drive shaft

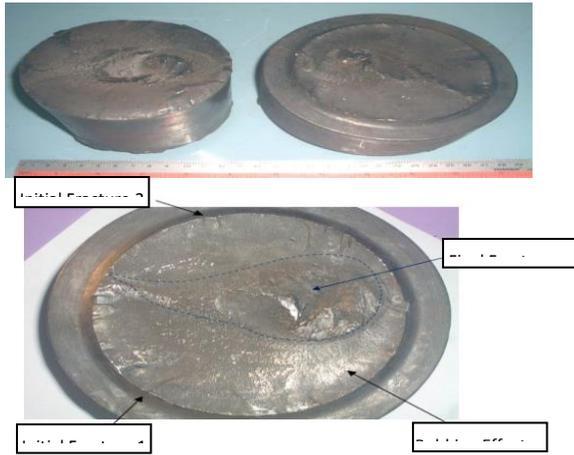
Figure 4. The fracture surface because of rotating bending

Based on the observations on the photographs of the fracture surface in the shaft, the expected area as crack initiation, and the crack propagation spreading into the shaping beach mark shown in Figure 4 were done. The final fracture occurred in end of the cycle stress when the rest of the shaft cross-section no longer able to withstand the load of shaft. Fatigue fracture could be recognized from the fracture surface. It was smooth due to the rubbing effect when the crack spread as a result of loading cycles, while the final fracture surface looks rough (Figure 4)

2. The rotating bending causes the loose-fitting of pegs in tooth whell which leads to the beat / clash between two tooth whells, so that the reverse impetus occurs from driving gears in the fillet. Those indications are strengthened by figure 4 and 6. These phenomena continously happens during the operation of drive shaft, until the loose-fitting and the scrape continously happens in keyway area (figure 3). The friction between the peg and keyway cause continuous collisions which makes cracks and spread into the final fracture (Figure 4).

1. A test of material hardness, clams composition , tensile , metallographic and SEM.
2. A heat treatment process on the drive shaft so that the material yield strength increases.
3. An analysis of friction in the keyway of the drive shaft and the worm screw stopper.
4. An analysis of friction in the keyway of the drive shaft and the keyway of the tooth wheel
5. An analysis of vibration in the worm screw.
5. A penetrant test to hub screw worm before the operation and during maintenance.
6. A control to make sure the dough in degester that goes to screw press does not lack of water because it can reduce the burden of pressure.

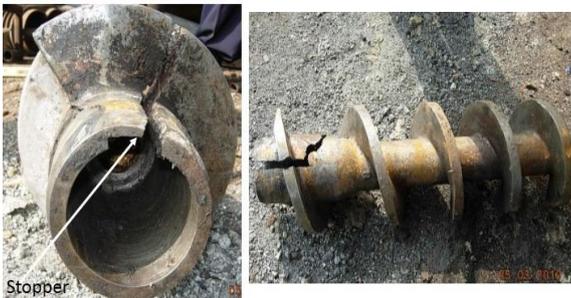
Figure 5. Worm screw damaged

1. The effect of loose-fitting post on the worm screw of the drive shaft. In addition, the concentration of stress on the keyway area (figure 6) makes rotating bending at the worm screw. It can be recognized by the presence of cracks / damage in the worm screw stopper area (Figure 5). Finally, it lead to the

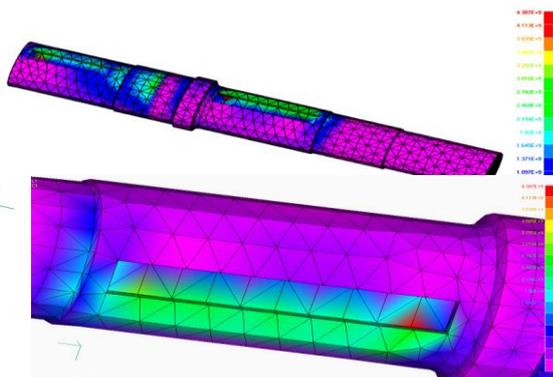
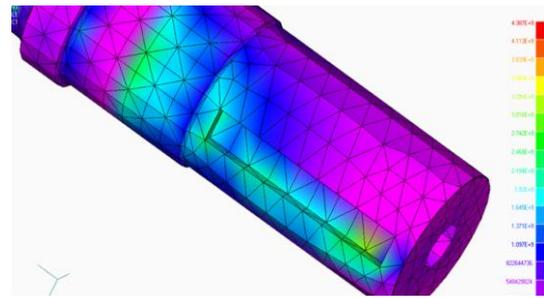
Figure 6. Contour concentration stress in drive shaft [4]

Based on the stress simulation results using MSC Nastran software as shown in the Figure 6 shows that the maximum stress (to the power of shaft) that occurs in the shaft was $4.387E+9 = 4387000000 \text{ kpsi} / 6,895 \times 10^6 = 636, 26 \text{ N/mm}^2$. It explained that the stress that occurred was still in the safe limits of tensile strength which is $800-950 \text{ N / mm}^2$ (Table 1). However, the concentration of stress occurred on the keyway area and it made uneven distribution of stress on the shaft so that the fatigue happened in that area. If the allowable shear stress corrected is greater than the shear stress that occurs on the basis of the shaft without a keyway, the dimension of the shaft is safe / good. But if the result is less, redesign must be done to make the greater results [5].
